EQUIPMENT ACCEPTANCE SIGN OFF SHEET FOR MTR-2

EQUIPMENT DESCRIPTION: Top Drive

VENDOR: NOV.

DATE: 4th April 2008.

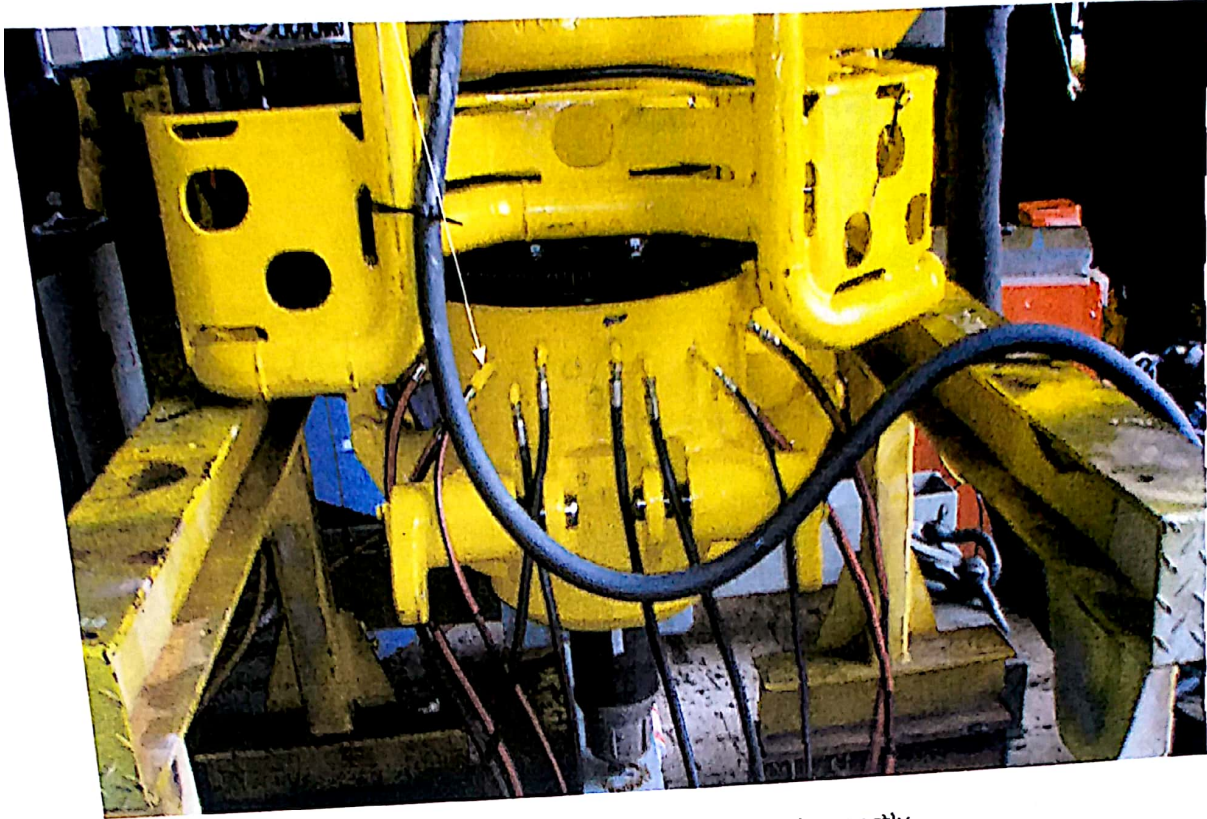
FIG #4

The top drive plug in connections were checked and found to be secure. The support bracket for the cable tube had been modified previously, and spacers added, but it will be reverted to its original NOV recommended set-up, so as to ensure a safe and secure fixing of the tube.

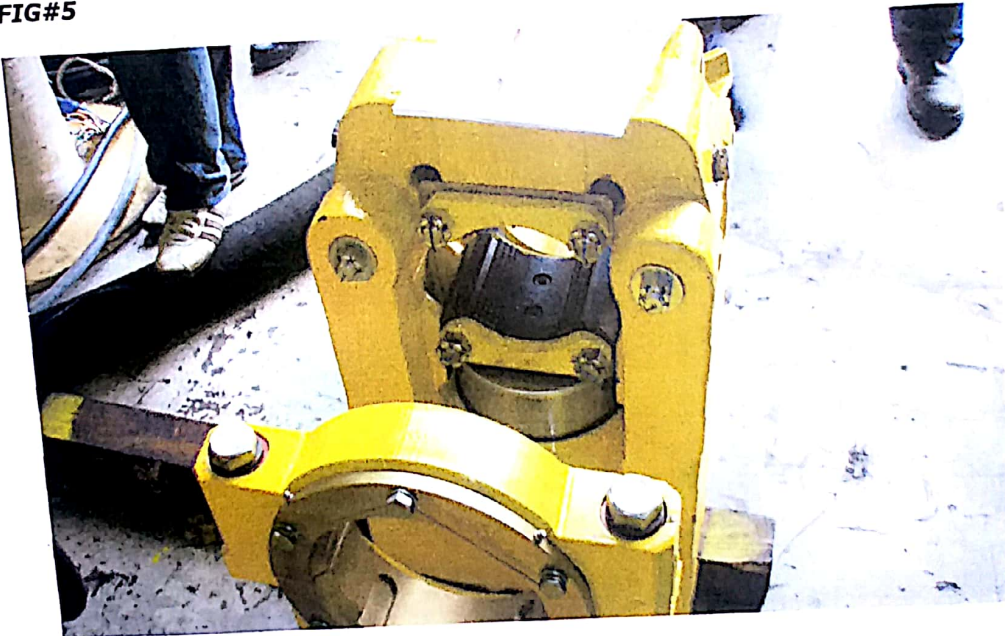
FIG#5

Rotating head was operated in both directions and functioned correctly.

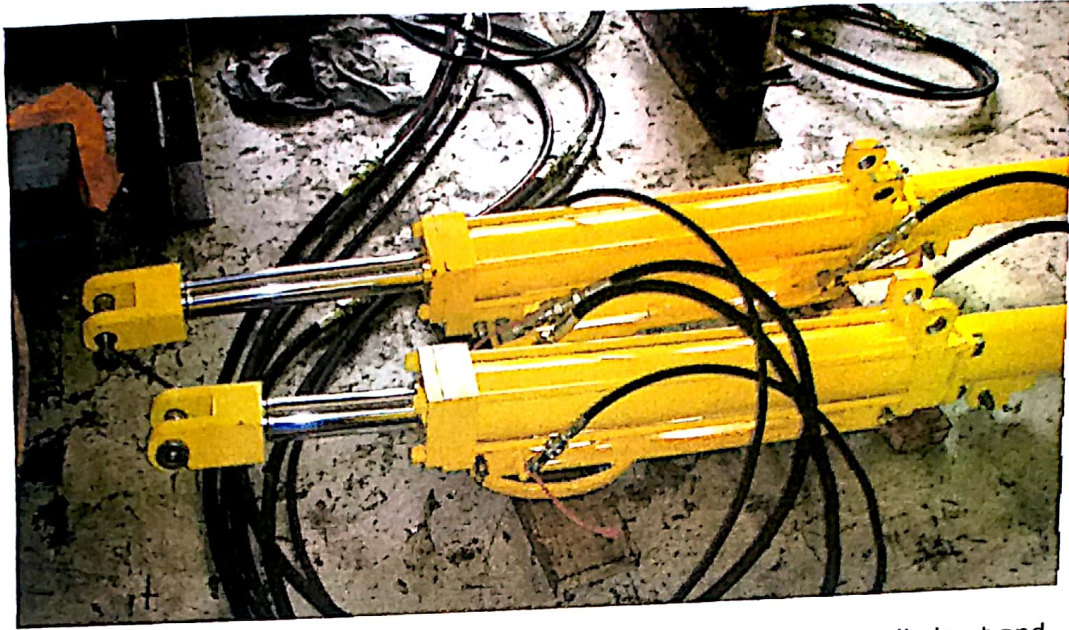
FIG#6

The pipe clamp was function tested and operated correctly in both directions.
